Code Inspections and Enforcement
County Office Building
111 W Chesapeake Ave
Towson, MD 21204

Re: Code violations at 11717 Belair Rd, Kingsville Motors

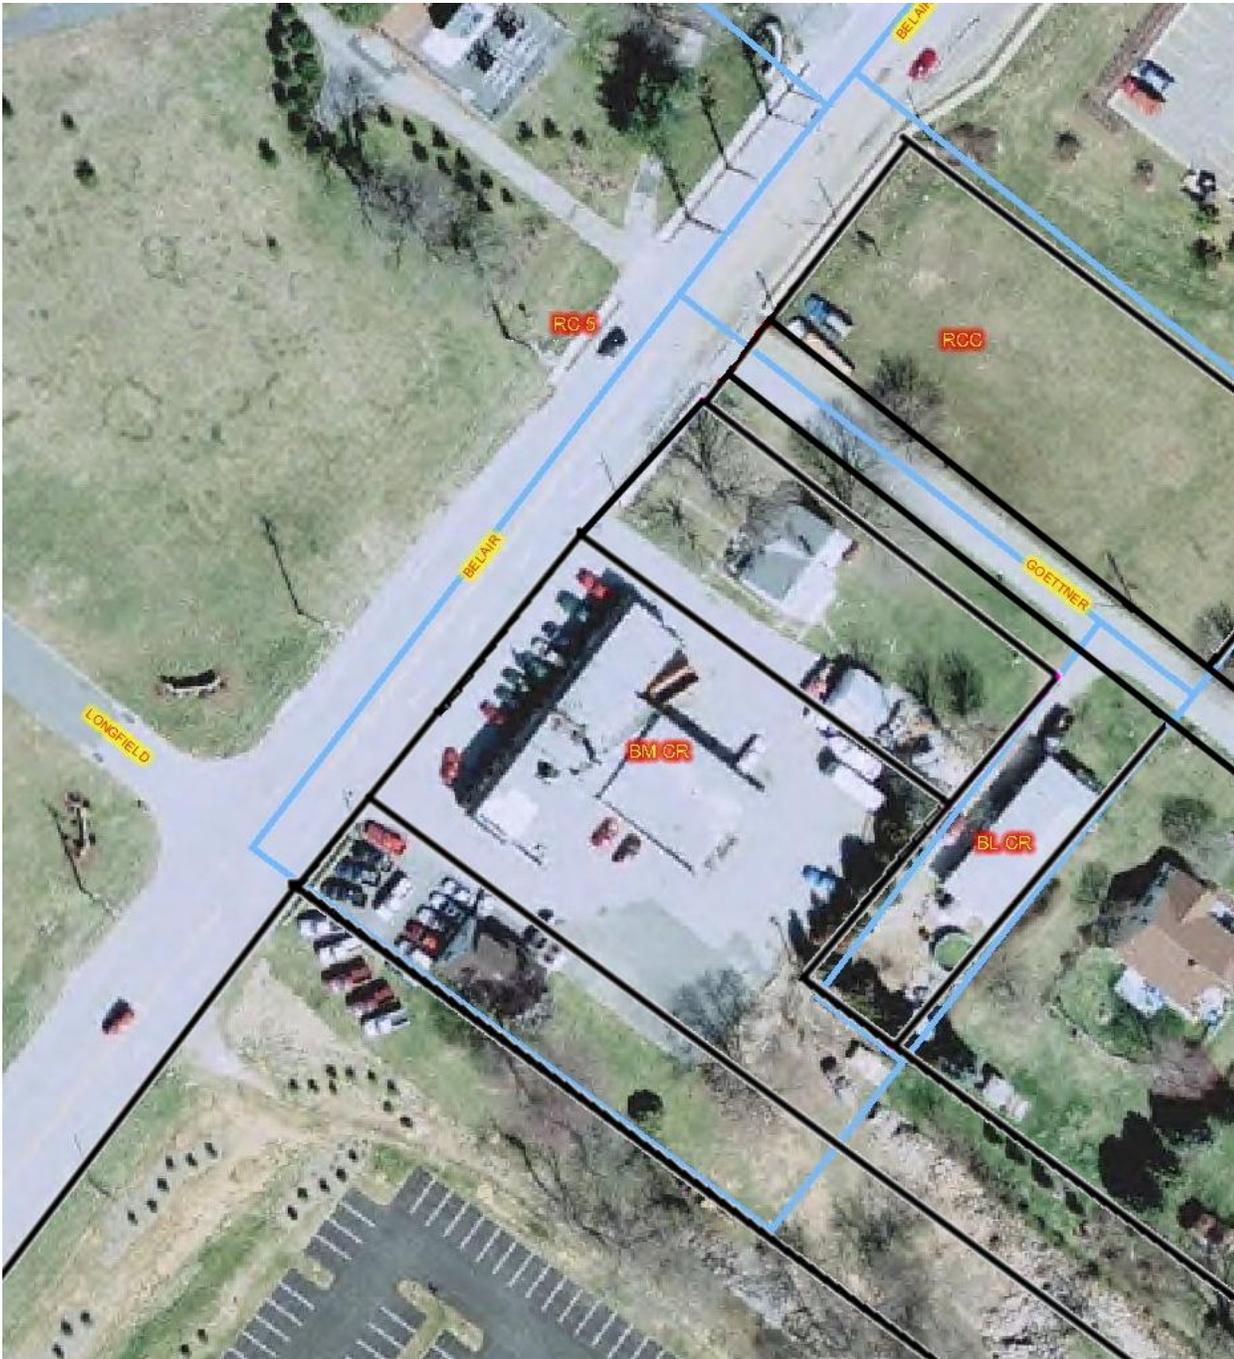
I request that you investigate and issue correction notices as appropriate for the subject property. This property is zoned BM CR as shown in the attached Figure 1, which is an aerial photo with blue zoning lines as found on the county Web site. I have overlain black property lines for reference. This BM CR area is adjacent to RC-5 and RCC zoned areas. The area consists of three parcels (P.265, P.292, and P.266 on map 64) owned by this dealership as shown on the attached Figure 2. In addition, the area of violations includes a 14.55 ft strip along Goettner which is a part of an L-shaped parcel (P.424) containing a house located to the rear of the dealership. The house portion to the rear is zoned BL CR due to a previous gift shop in this house. I have heard that there is some sort of agreement between the owner of this house and the Dodge dealership for the dealership to use this 14.55 ft strip in exchange for providing a buffer between themselves and the residence.

Figure 1 - Blue lines from County Web site, black property lines (approximate location) added for reference (Note: Houses on north and south-most parcels have been removed.)

According to the information contained on the Baltimore County web site, a portion of the area being used for this business is not zoned BM, but rather RC5. The attached aerial photo from the web site (Figure 1) shows the extent of the BM zone (which apparently coincides with the property lines). In this photo, as at present, vehicles for sale are parked beyond the extent of the part zoned BM on the southwest side. In fact, it would appear that they are on the neighboring church property. (Note the edge of the BM zone relative to the location of the wooden guardrail and its alignment with Longfield Dr. on the opposite side of Belair Rd in this aerial view and the parked vehicles shown in the attached photo #8.)

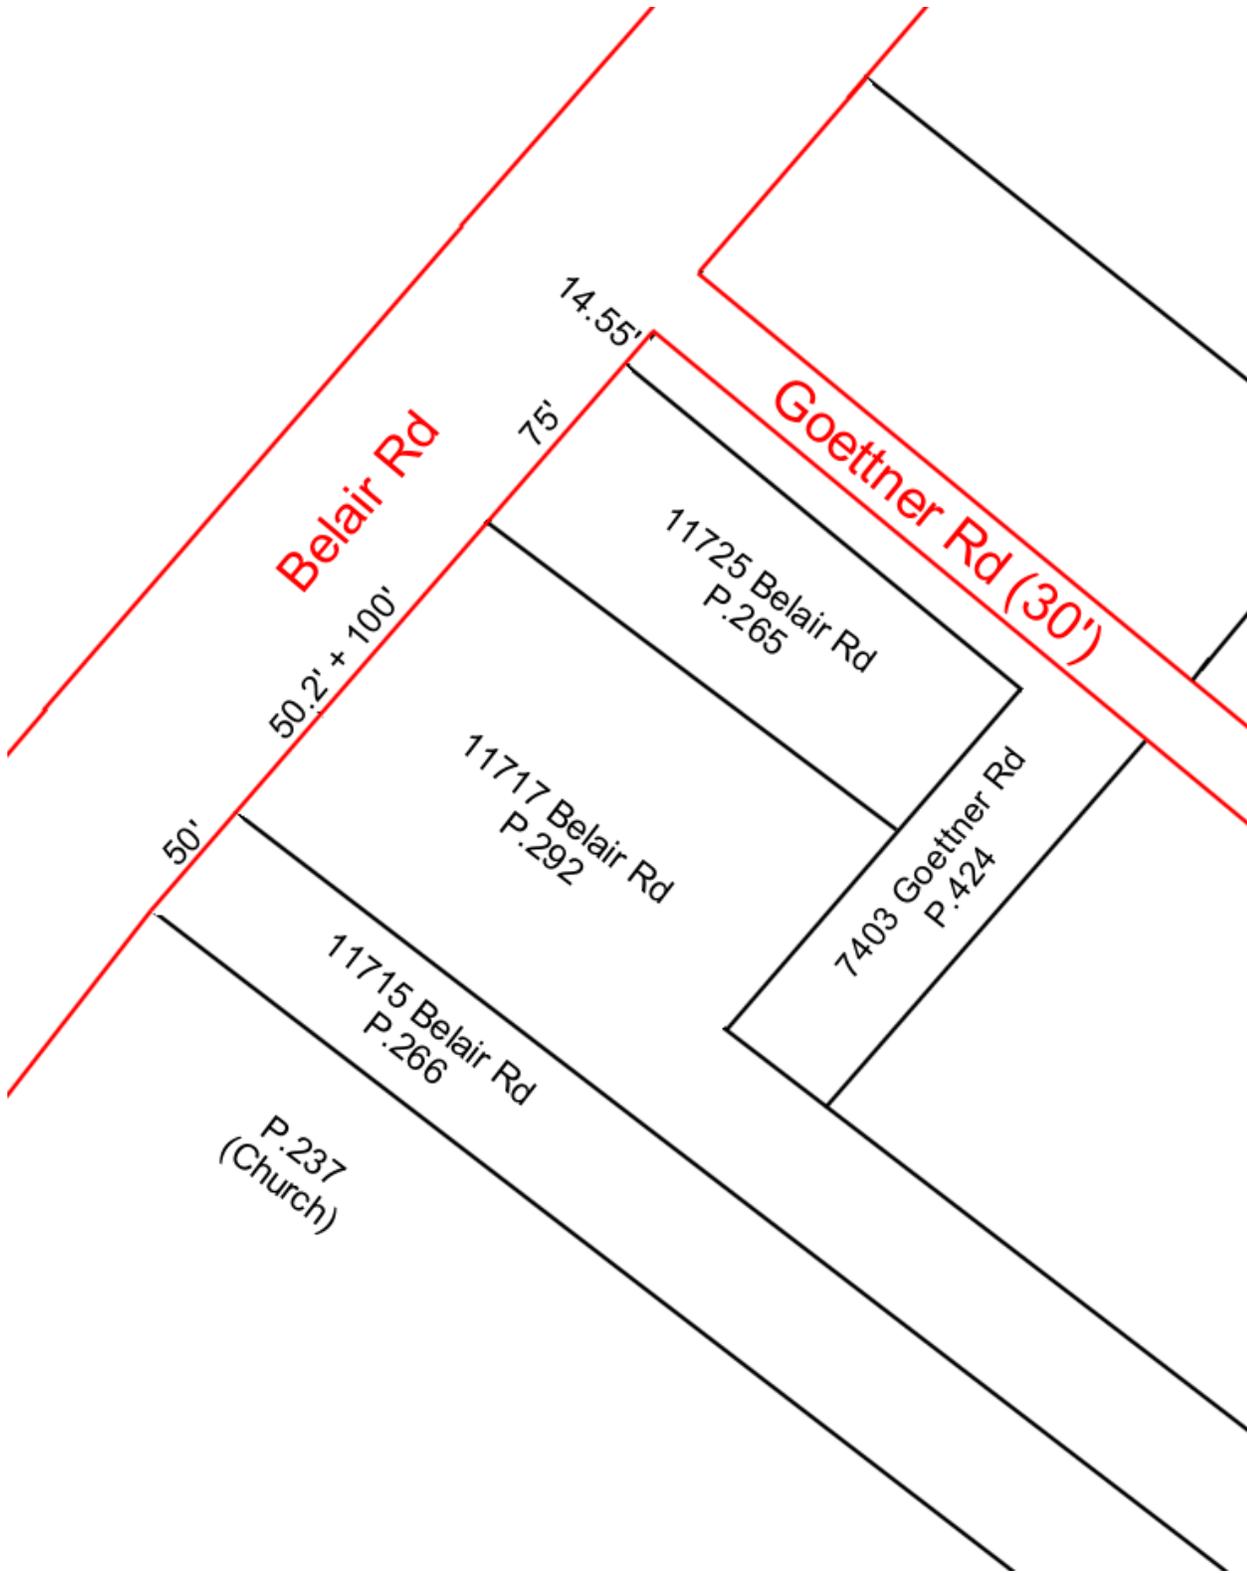
Figure 2 - Parcels involved - Dodge dealership is P.265, P.292, and P.266. Also using 14.55 ft strip of P.424

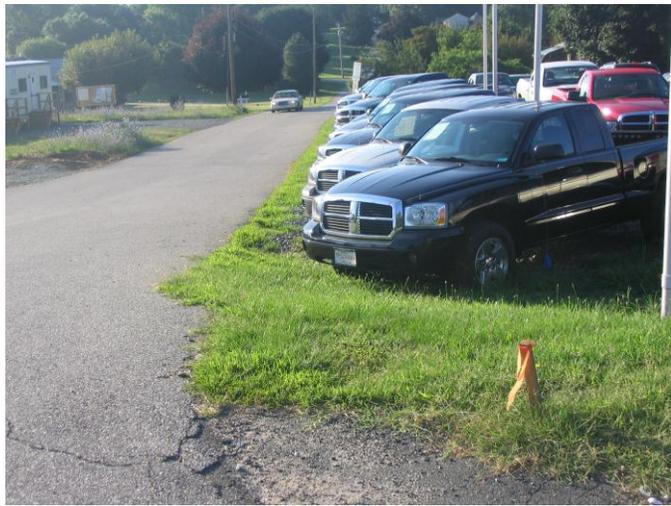
As shown in the enclosed photos #1a and 1b, vehicles are parked too close to the adjacent Goettner Rd. The survey stake in the photo is inscribed "Prop cor", and I believe it is the north-most corner of the L-shaped parcel. The parked vehicles are well beyond this property line into the road right-of-way, sometimes even blocking sight of the traffic sign. § 235.2 requires a 10 ft "sideyard" (as stated in § 232.2B) and it must be landscaped.

#1a 7/24/05 Vehicles parked too close to Goettner Rd

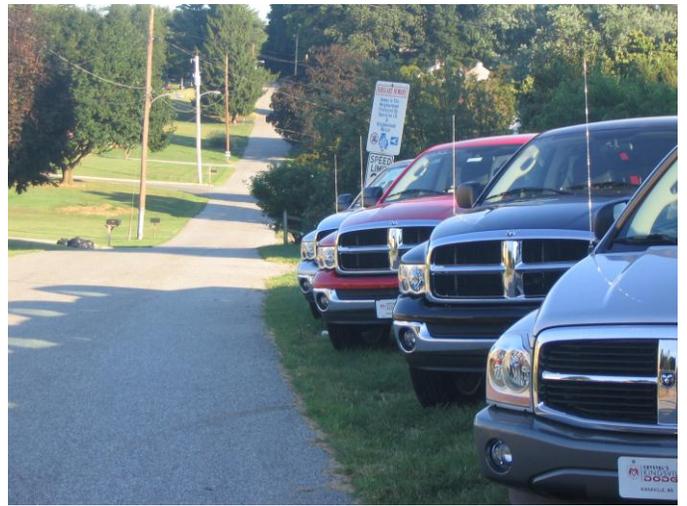
#1b 9/4/05 Vehicles hiding part of traffic sign

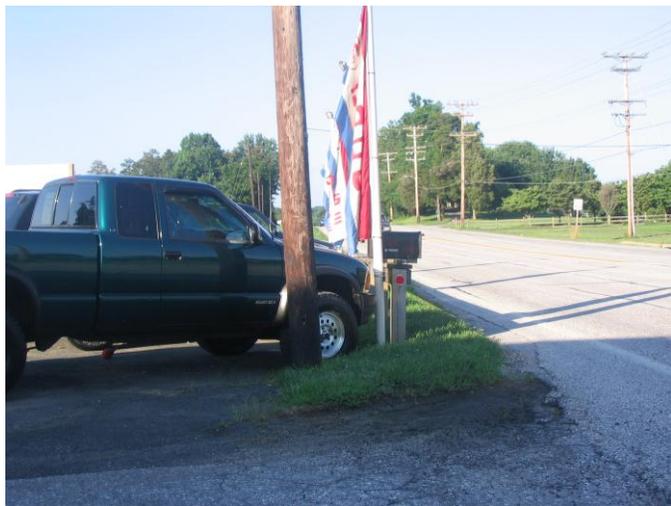
As shown in the enclosed photo #2, taken from the driver's window while trying to pull out onto Belair Rd from the parking lot, there are banners erected close to the road, in a way which obstructs the view of drivers exiting from this lot. These banners extend into the road right-of-way when the wind blows from the east. Oncoming traffic on Belair Rd usually far exceeds the 40 MPH limit at this point, making this very dangerous.

#2 7/24/05 View for drivers exiting parking lot

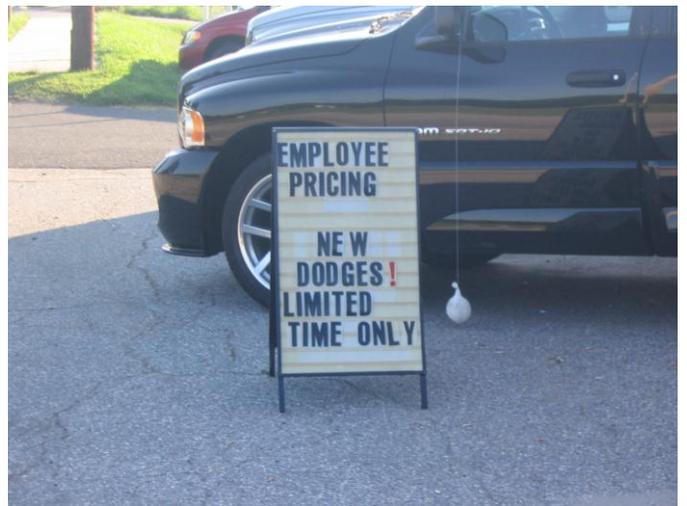
The portable sign with changeable letters shown in photo #3 (outside of business hours) is not allowed.

#3 7/24/05 Portable sign with changeable letters

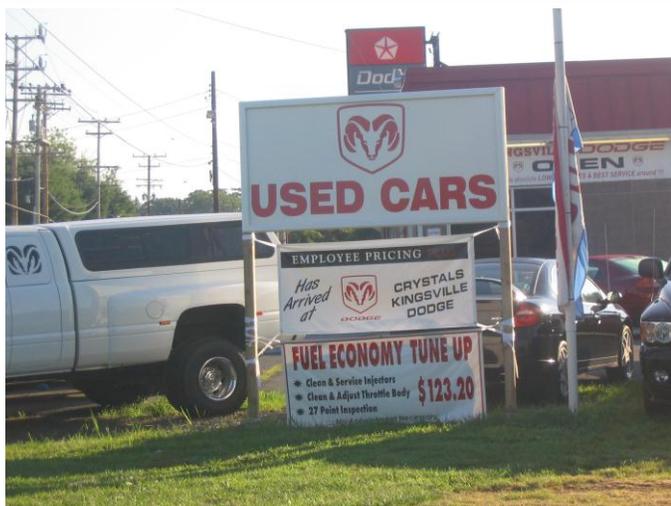
The signs shown in photo #4 are non-permitted. Even if permitted, they are less than the required 25 ft from the adjacent residential zoned property.

#4 7/24/05 Non-permitted "permanent" sign

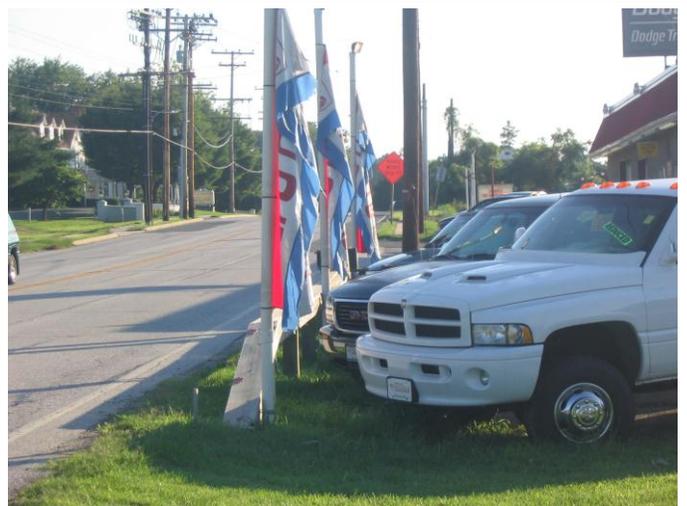
As shown in photos #5a, 5b, and 5c, vehicles are parked too close to, and in, the right-of-way of Belair Rd. The front edge of the property is near the rear of the sidewalk as indicated by recently placed survey stakes. According to § 235.1, the minimum front building line is 15 ft behind this line

and according to § 259.3C7d, goods may not be displayed more than 5 ft in front of this required building line. This should mean that these vehicles displayed for sale must be at least 10 ft behind the front property line. These vehicles parked near Belair Rd are a constant hazard for traffic exiting from Goettner Rd.

#5a 7/24/05 Vehicles too close to Belair Rd - looking north

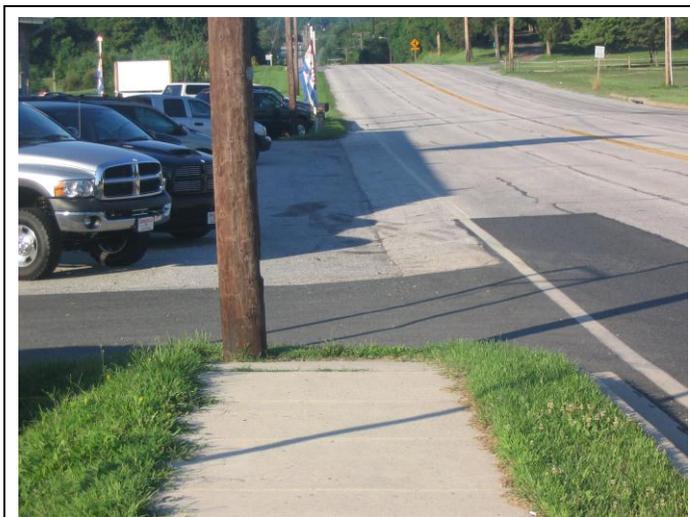
#5b 5/24/05 Vehicles too close to Belair Rd - looking south

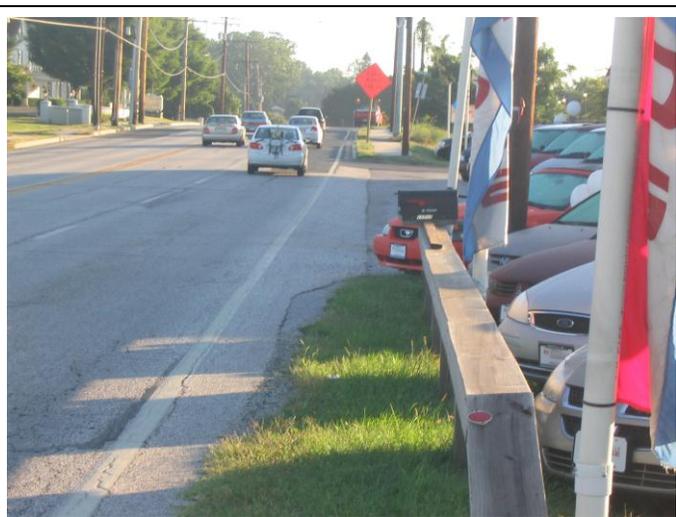
#5c 9/6/05 Vehicle partly in right-of-way

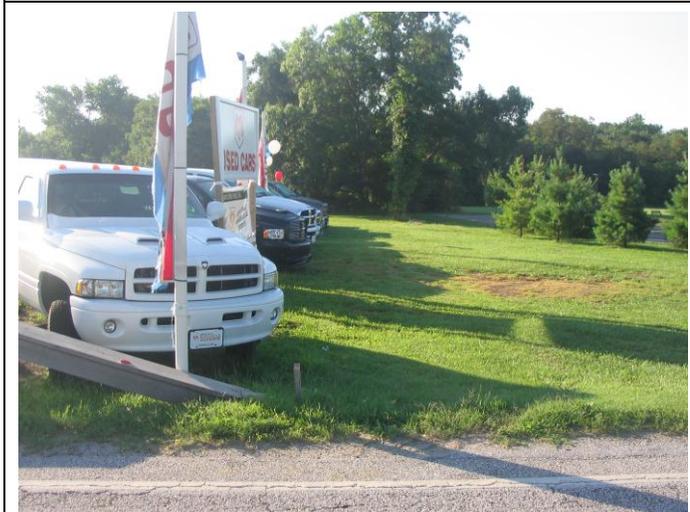
The vehicles parked on the southwest side of the property, as shown in photo #6 are too close to (and sometimes on) the adjacent residential zoned property. A 10 ft "side yard" is required. A stake, presumed to be the property corner, can be seen at the bottom of the photo, just at the end of the guard rail, however, this location is not consistent with the aerial photo in Figure 1. Further, § 259.3C3 requires that this space be landscaped.

#6 7/24/05 Vehicles along south side of property

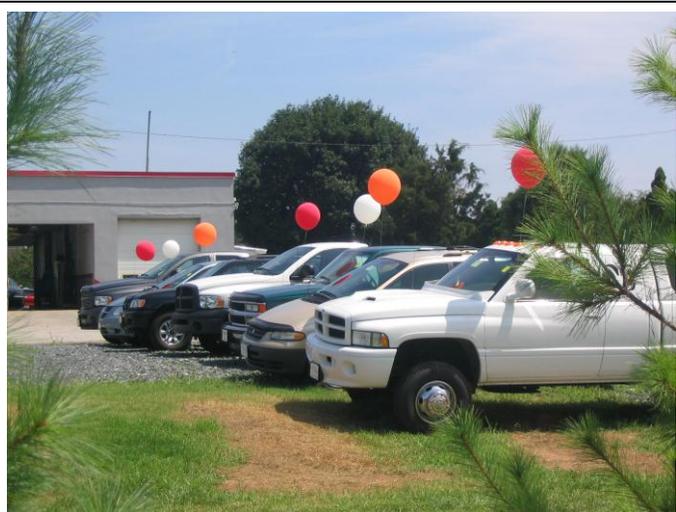
The balloons in photo #7a are prohibited as "tethered balloons". This is a regular occurrence. The high balloon (photo #7b) has been there at occasional times. Several months ago, upon seeing it, I went into the office to inform the manager that this was illegal and asked her to remove it, to which she replied "I'll take it down when the County tells me to." I then telephoned a complaint to your office, and several hours later the balloon was gone.

#7a 8/5/05 Vehicles with balloons

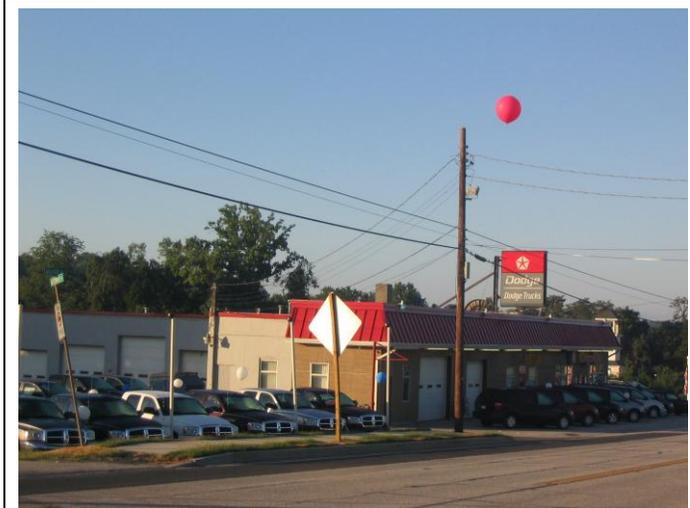
#7b 9/6/05 Tethered balloon

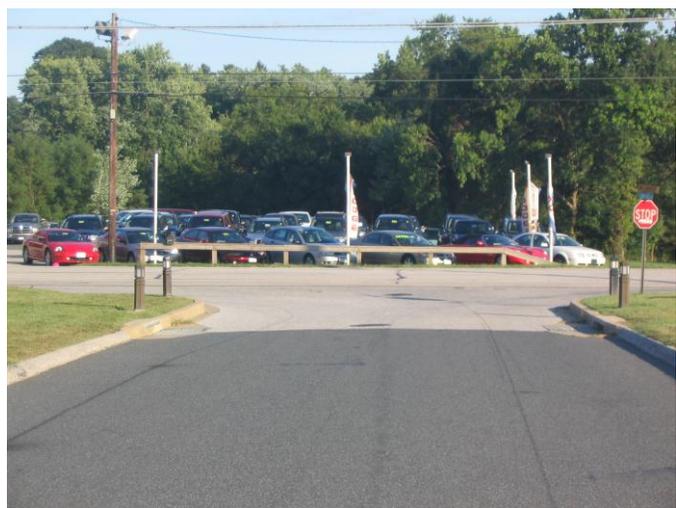
#8 9/4/05 View from Longfield Dr.

There will likely be a disagreement over the exact location of this southwest boundary, however, it should be easy to measure 275.2 ft from the property corner chiseled into the sidewalk at the north corner.
